UVIT-PMB

Mechanical Structure:

INDIAN INSTITUTE OF ASTROPHYSICS
BANGALORE

EM structure, and Vibration Tests (modifications indicated)

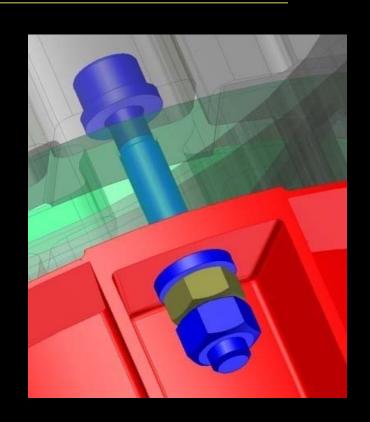
A set of three M5 bolts in the support for the secondary mirror loosened during random vibrations of qualification level.

These M5 bolts were replaced by M6 bolts which should give a 40% larger preload.

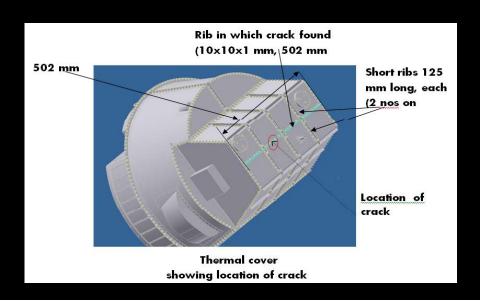
A Crack spotted in the rib of thermal cover: Failure is attributed to the fatigue, associated with joint design, refurbishment of joints are as follows.

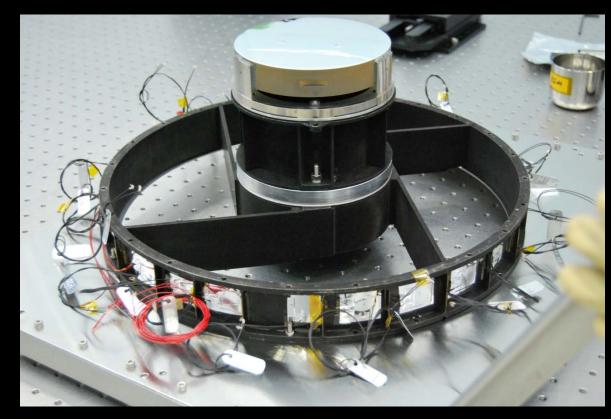
Torquing of the mirror interface's and optical mounts needed special care to control astigmatism.
