**Test Report
On
Engineering Model Detector (NUV Channel)
Of
UVIT Payload**

Version 0.2

**INDIAN INSTITUTE OF ASTROPHYSICS
Koramangala,
Bangalore-34**

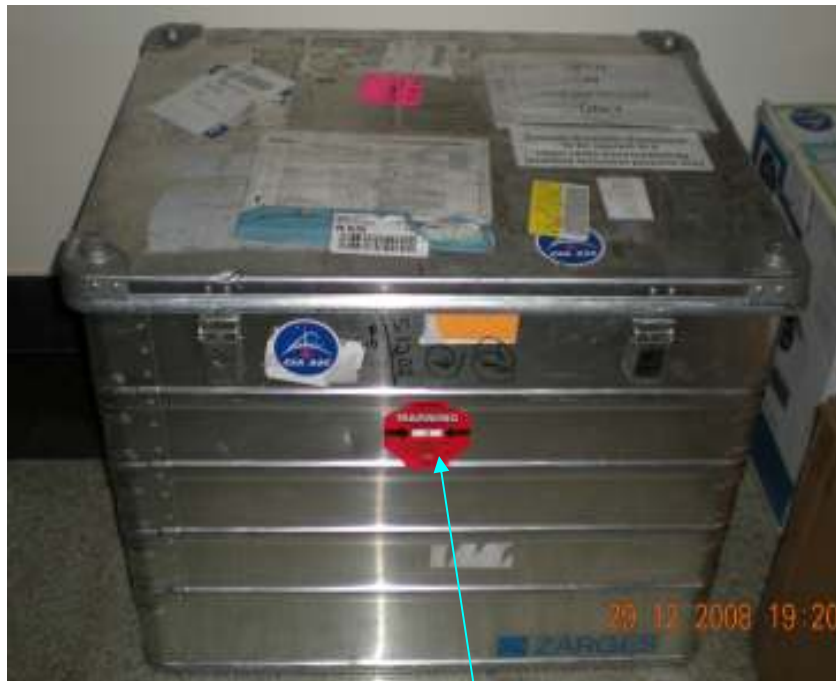
Figure 2. 1 HVU Box with RED Shock Watch Monitor

UVIT EM DS arrived in MGMK lab IIA at hosakote on 29th Dec 2008 in evening. All the boxes [Total 8 Boxes; {CPU, HVU, EGSE, EU, Cables, Transformer, Printer, Gasket}] were unloaded and snaps were taken while after unloading. After unloading it was found that Shock Watch Monitor on CPU and HVU boxes was RED, rest other boxes' shock watch monitors were correct. The packing boxes of EU and CPU were having cuts on them. All the boxes were kept in 3Lakh Clean room after cleaning with vacuum cleaner.

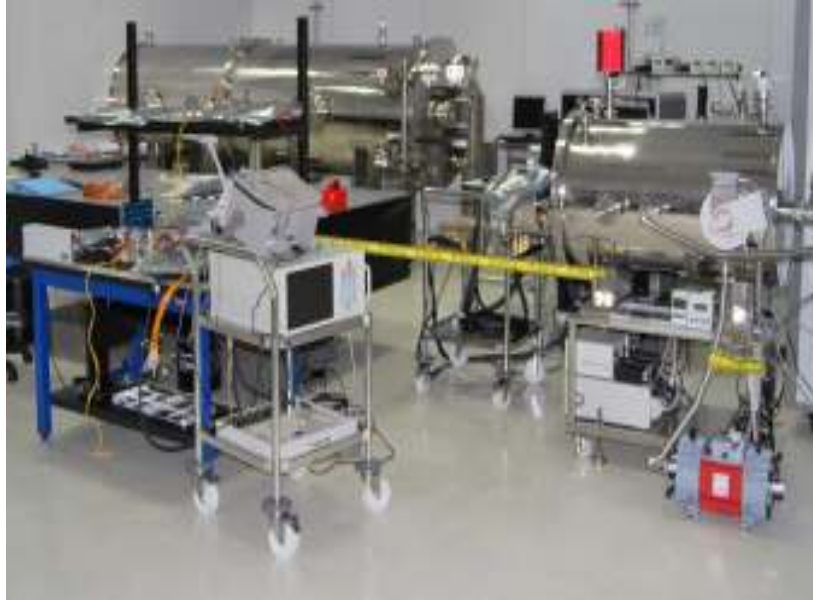
Figure 5. 5 ISRO EM-DHU and UVIT EM-EU interface Test Setup

- 1) Micro Channel Plate (MCP) voltage of HVU Vs Photon Counts. In that MCP voltage varied from 2020V to 1750V in step of 50V.
- 2) Interface test of EU with ISRO EM DHU (Data Handling Unit). In that imaging data has been taken through EM DHU instead of EGSE DHU. Electrically this test was successful, DHU team has taken all the clock, request and data timing waveforms from both channel (Main and Redt) and the results are as satisfactory. A detail report on this test will be prepared by ISRO DHU team.
