UVIT-PMB

Mechanical Structure:

INDIAN INSTITUTE OF ASTROPHYSICS
BANGALORE

EM structure, and Vibration Tests (modifications indicated)

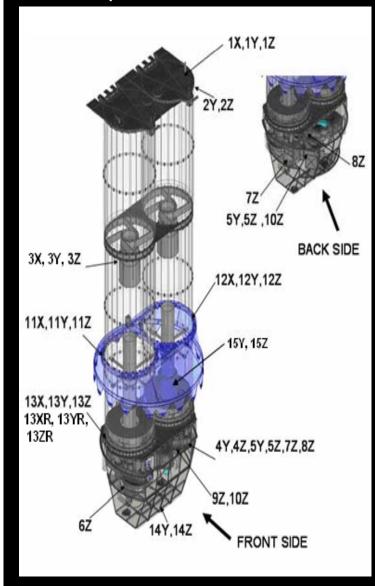
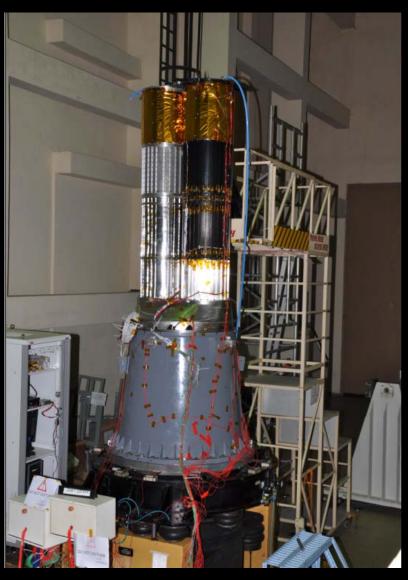
The vibration test was conducted for "sine", "random" and 15 g quasistate loads as per the qualification load specs (isro).

The qualification tests on the payload were successfully completed. The mechanical integrity of the payload was established by pre and post signature test data. The mechanical alignment stability before and after the qualification tests were correlating. The functional tests of the payload were satisfactory.
